Take Control of Quality Assurance
Underground Pipeline Coating

**Coating Scan
Technology**

A white paper
from Element Integrity Group, Inc.

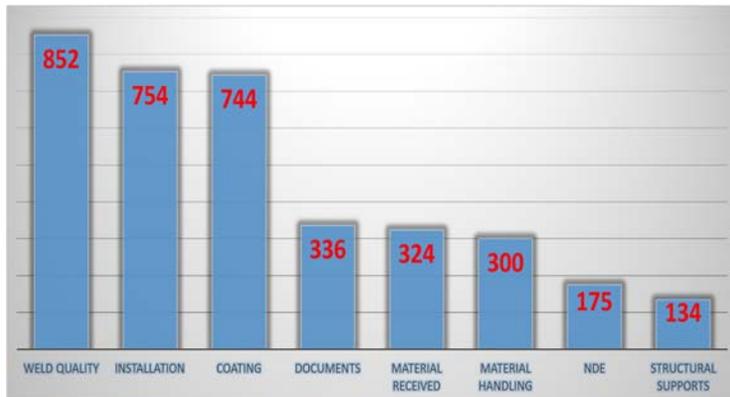
Why is data that is nearly 6 years old still relevant? Let's take a look at Element Integrity Group's own data from 2014.

Please note why coating issues was not our number one finding, it is just as prevalent an issue today as it was 6 years ago. This thorough quality assurance inspection discovered 744 potential defects that would have been buried and put into service. After burial was complete on this same project, C-Scan uncovered over 50 more anomalies. These anomalies were the result of mechanical damage during install/backfill and of poor coating application at the butt welds.

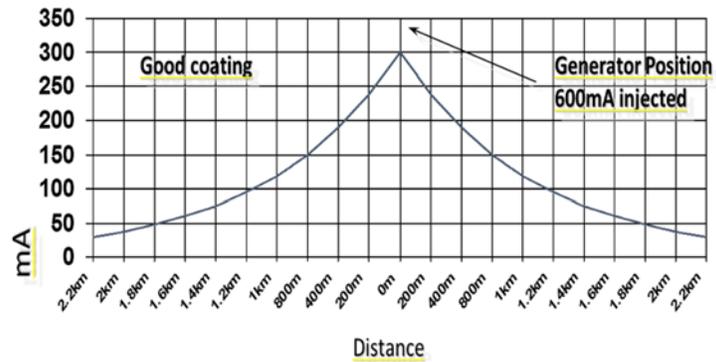
Coating Scan functions by measuring the attenuation of an A.C signal conductively applied to a pipeline.

That low frequency A.C. signal will gradually be lost to the surrounding soil through the pipelines resistive coating as it passes along the buried pipeline. This is the Rate of Attenuation as can be seen in the figure below.

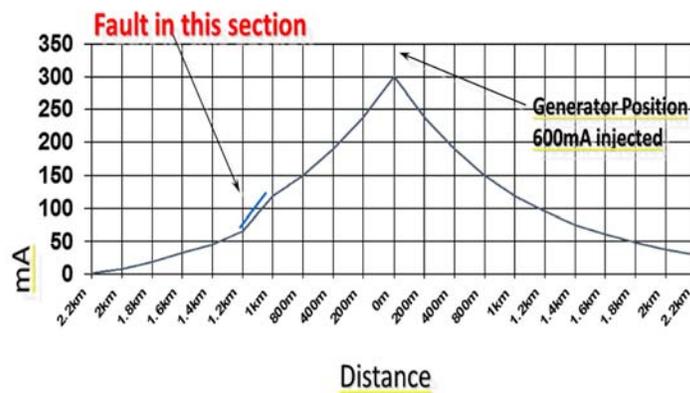
Where the coating is decaying or damaged, there is a significant increase in the rate of current loss. This is an Increase in the Rate of Attenuation. In the figure below you can see a slight step change in the exponential curve of the AC signal.

Shot locations can vary along the survey chainage information is gathered via the on board GPS.

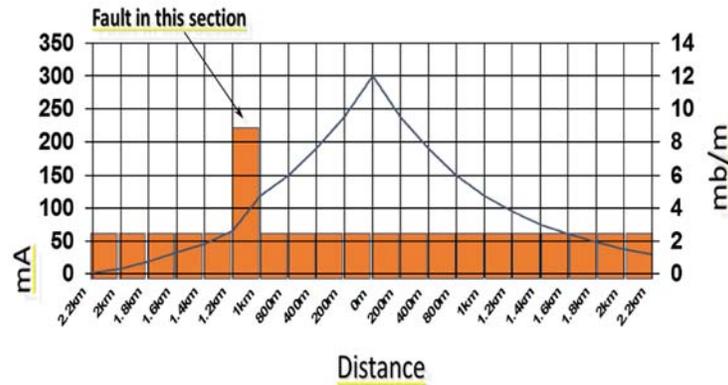
The fault can be clearly seen when logarithmically plotting this curve. The rate of current loss over any section of pipeline measured in millibels per meter (mB/m), is effectively an absolute measure of the average quality of the coating over that section. The fault can be clearly seen in the graph below.

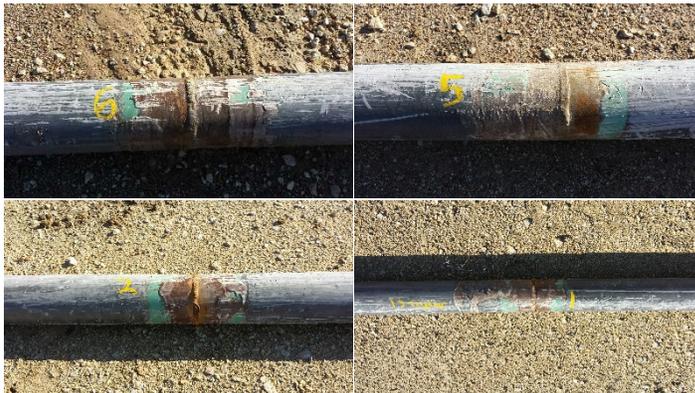
Due to the conflicting recommendations by the two technologies utilized to assess the line and the 87% success rate of the C-Scan findings for the owner/user, the decision was made to pull the bore. The results were very eye opening as can be seen in the photos below.

The bores were approximately 300 to 400 feet in length and were electrically isolated. The line in question, a 4 inch liquids line, was independently surveyed with C-scan. The survey indicated a large anomaly in the range of 40 millisiemens at the crossing. A bore profile drawing was provided by the owner/user which indicated the pipe depth to be in the 12-15 foot range. It was determined the line would be taken out of service and further evaluated before a repair would be scheduled. The bore was exposed on both sides and a cut was made so a "smart pig" could be deployed to further assess the line. It was discussed up front that Coating Scan Technology only looks at coating integrity and not wall loss and that the internal tool would be looking at wall loss and not coating.

The internal "smart pig" inspection found no anomalies with the line and recommended the bore not be replaced.

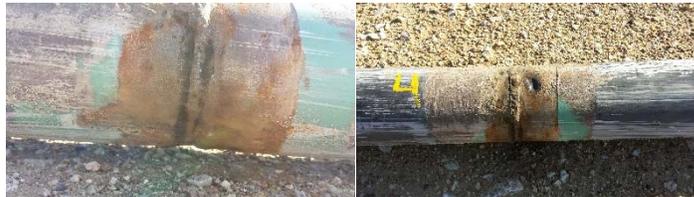
The bore consisted of 6 joints of pipe with an average length of 42 feet. The pipe was coated with an abrasive resistant coating. However, all of the girth welds joints had been coated with a tape wrap. This wrap was removed or “wiped” off while the pipe was being pulled through the bore leaving the entire heat effected zone bare. Severe metal loss was found from 3-6 o’clock positions on the girth weld location number 3 (see left photo below). Weld number 4 (see right photo below) had a corrosion cell that measured .187 in deep on a .237 in wall pipe.
